V. Types and magnitude of recent soil erosion in the study area

1. The erosional forms and their dependency on the anthropogenic relief

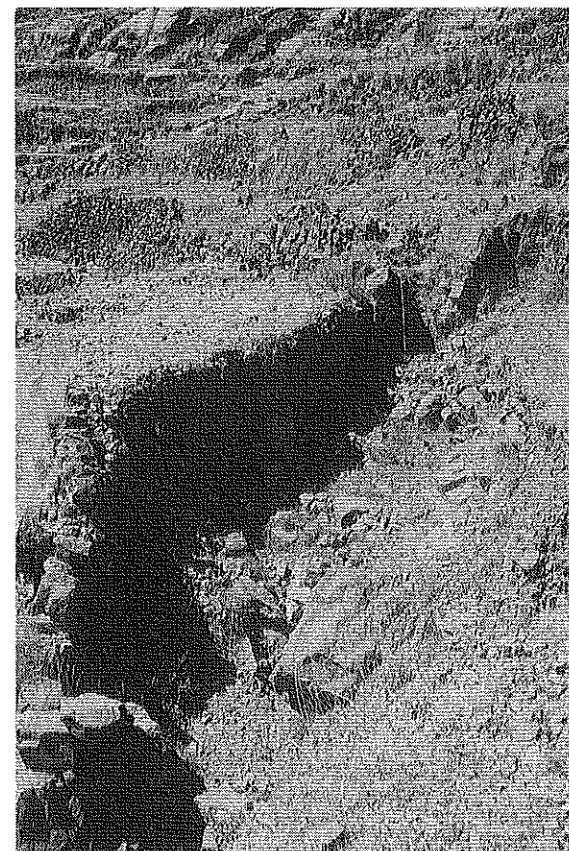
Photo 12: U-shaped, i.e. axial gully.

Length: approx. 10 m
Width: approx. 3 m
Depth: approx. 2-2.5 m
Map coordinates:
65.05/62.85

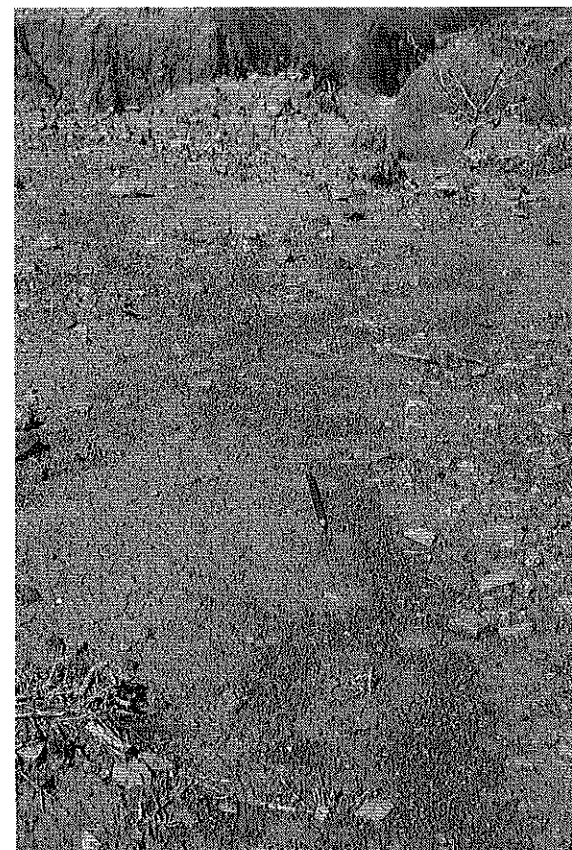
Photo 14: Diffuse thread-like flow lines and rills.

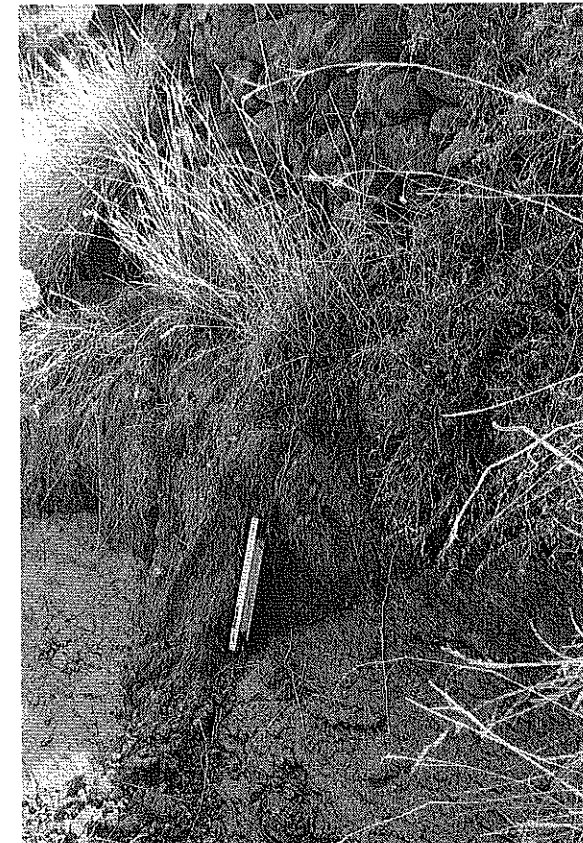
Photo 16: Soil profile remnant on highly porous tuff (on the Mankhah - Al Hutayb dust road west of Az Zahrah).

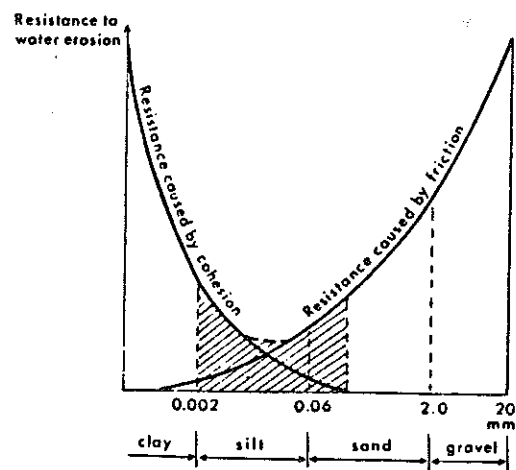
Fig. 17: Erodibility of various particle sizes.

This clear tendency for silt particles to be removed in preference to other fine soil fractions has been confirmed by the soil-loss studies performed over a period of years by L. JUNG and R. BRECHTEL (1980, pp. 105-107). According to the comprehensive results of their investigations, the silt particles are the first to be washed out, and this occurs even when the forces acting upon them have low erosivity. Comparable findings were made by U. KIHLMOM (1970, cited in Jansson 1982, pp. 24-25; see Fig. 17).

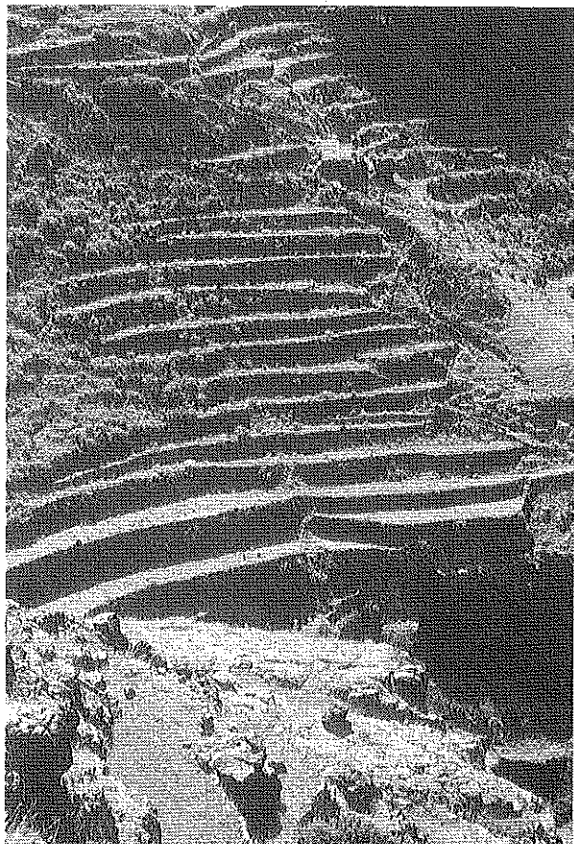
Photo 23: Gully "breakthrough" in a recently abandoned terrace complex on Jabal Shibam (looking towards the east).

stretches (terrace fields) (cf. Photograph 23). If short gullies still in the process of formation emerge onto still (largely) intact horizontal terraces, then the tractive force and carrying capacity of the stream-like runoff are checked by the sudden flattening of the slope and spreading of the water just as abruptly and drastically as they had previously been increased by the effects of channeling and free fall. Consequently, part of the previously eroded enormous quantities of transported soil is deposited at such breaks in the slope in the form of small alluvial fans or taluses and/or colluvial layers.

One of these two terrace complexes was situated at 2,730-2,750 m above sea level on a westward-facing steep slope (30°) on Jabal Shibam (63.70-64.40) (see Photograph 23); the other was located at 2,170-2,240 m above sea level on a northwest-facing medium-gradient slope (20°) near Manakhah (65.25-67.10) (cf. maps). The terraces on Jabal Shibam had been untended for 3 years at the time of my field studies in 1984, while farming on the terraces near Manakhah had ceased in about 1974, although the owner pointed out that the damage to the terraces by gullying did not begin until 1979/80. Even then, the first collapsing sections of wall were provisionally repaired with mounds of rock.

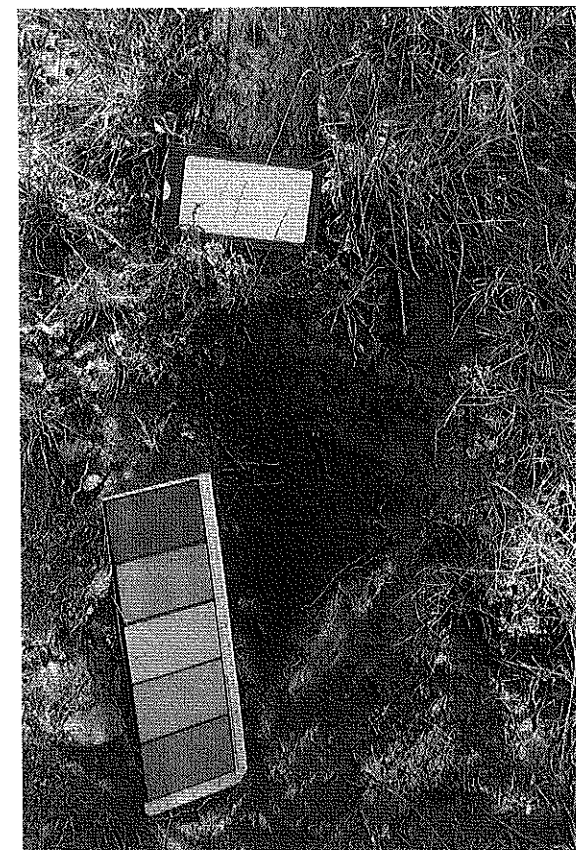
Photo 24: Residual soil depth on a formerly terraced slope (P 4).

The results of particle size analysis clearly revealed that only the silt fraction is highly susceptible to sheet erosion, while neither the clay nor the very fine sand fractions permitted any conclusions to be drawn (see Table 11). On all of the terraces - with the exception of T 8, which represents an unusual case (see Fig. 18) - the increase in silt in a horizontal direction and the enrichment of this separate in the surface horizon (see Table 11; cf. Table 9) are conspicuous. Selective washing-out and removal of the silt is also evidenced by the low silt fractions on greatly degraded sites (see Table 9 - P 4; cf. Photograph 24).

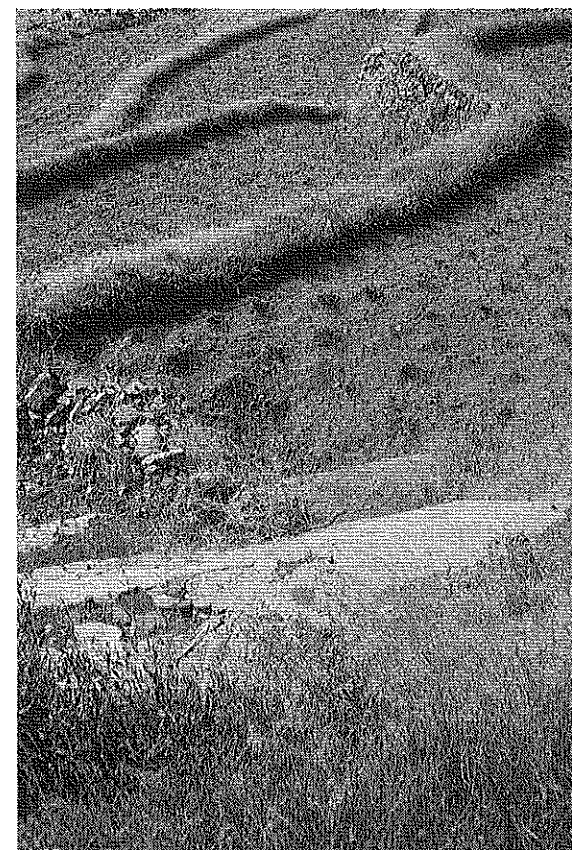
Photo 25: Conservation bench terraces with a simple diversion dam for utilization of runoff from a road (*sayl* irrigation).
Map coordinates: 63.05/69.25.

This piece of information is consistent with statements made by other farmers, who also pointed out that major damage to walls is typically the result of cloudburst-like torrential rains, and does not occur every year. According to the subjects interviewed, heavy rains of this kind fell in May of 1984, causing wall sections to collapse even in very well-tended terrace complexes (see Photograph 25).

The area surveyed near Manakhah is on the whole still in relatively good condition, although its terraces have already been incised by a large number of headcuts and short, discontinuous gullies (see Photographs 13 and 15). On the northern perimeter of this terrace complex, which covers a total land area of 5,230 m², the gullies were additionally fed by a culvert beneath the access road leading from Manakhah to Al Maghrabah; according to information provided by the owner of the terrace complex, after farming stopped on the terraces this culvert had been blocked by rubble for a long time. He also said that before cultivation had ceased, runoff water from the road had been used for supplementary irrigation of the fields (cf. Photograph 25).

2. Planting of grass on already strongly degraded slopes, including the possible use of "biological erosion control mats". These are net-like protective mats consisting of plant material and natural fibers, and (drought-resistant) grass and legume mixtures can be combined with them as required (cf. Hudson 1981, pp. 233 and 256-257).
3. Stabilization of the raised earth mounds that reinforce terrace retaining walls, by planting fast-growing, undemanding fodder grasses. This would permit the walls to additionally serve as erosion control strips and sources of fodder, a measure some farmers have already implemented on their own (cf. Photograph 25).

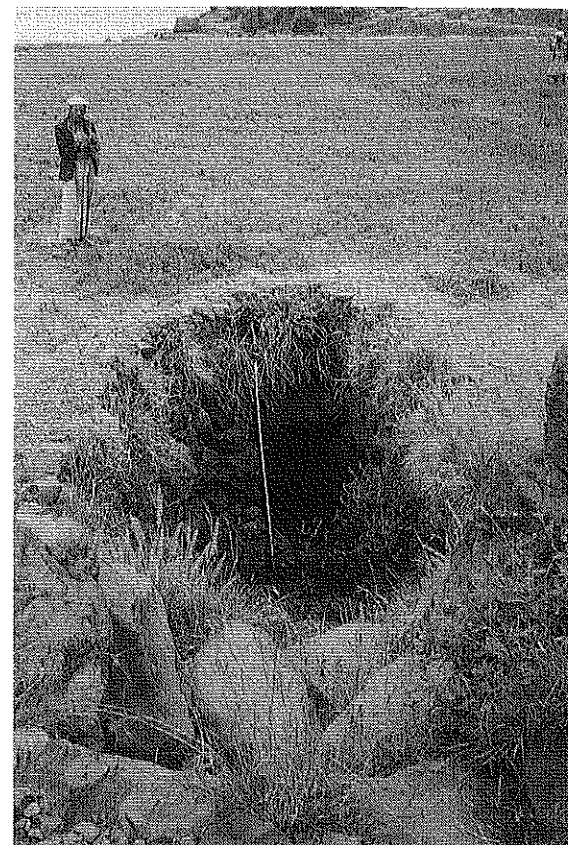
Photo 26: Inlet of an underground conduit at the back of a terrace.

Depth of basin: 2.3 m
 Height of underground conduit: 1.7 m
 Width of underground conduit: 0.8 m
 Length of measuring rod: 2 m
 Map coordinates: 65.05/62.85
